# Spatiotemporal Trends of Bora Bora's Shoreline Classification and Movement Using High-Resolution Imagery from 1955 to 2019

Emma Gairin, Antoine Collin, Dorothée James, Tehani Maueau, Yoann Roncin, et al.. Spatiotemporal Trends of Bora Bora's Shoreline Classification and Movement Using High-Resolution Imagery from 1955 to 2019. *Remote Sensing*, 2021, 13 (22), pp.4692. 10.3390/rs13224692 . hal-03762844

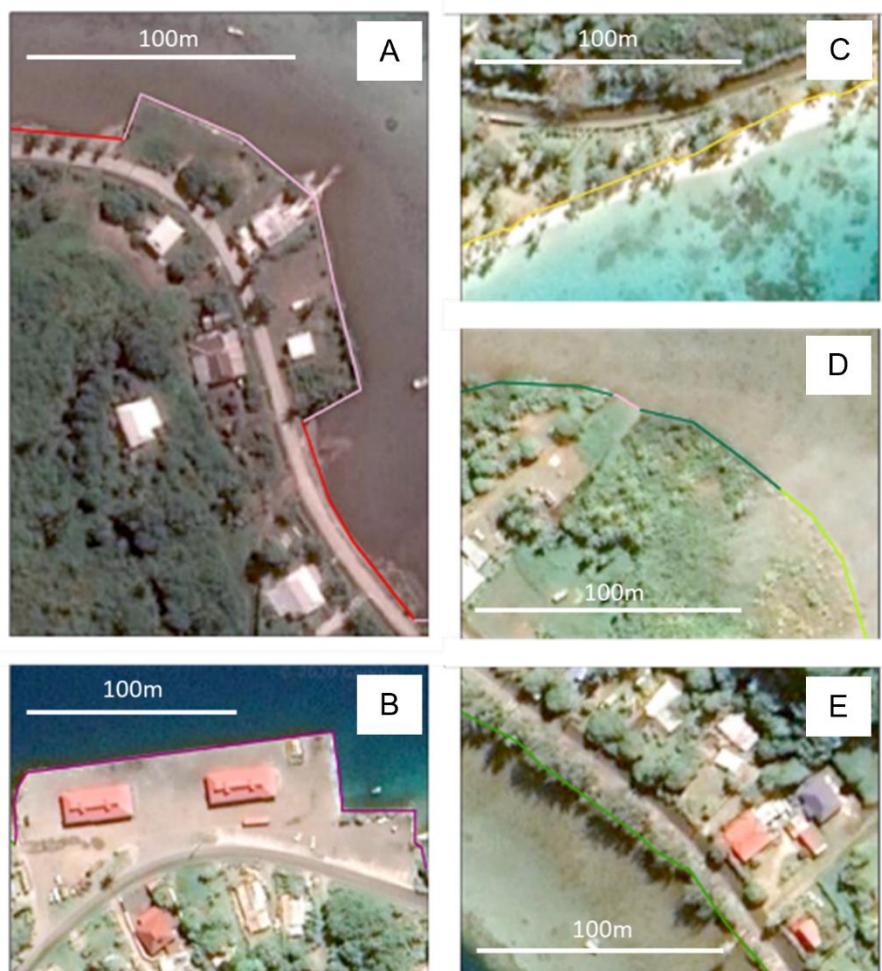
**Figure 4.** Examples of aerial view of coastal classes. (A) road embankment (red) and private embankment (pink); (B) quay; (C) sandy beach; (D) mangrove (dark green), grass (clear green), private embankment (pink); (E) trees.
